GLASS UNLIMITED

Technical Information – 09/2010

Risk of Nickel Sulfide presence in glass

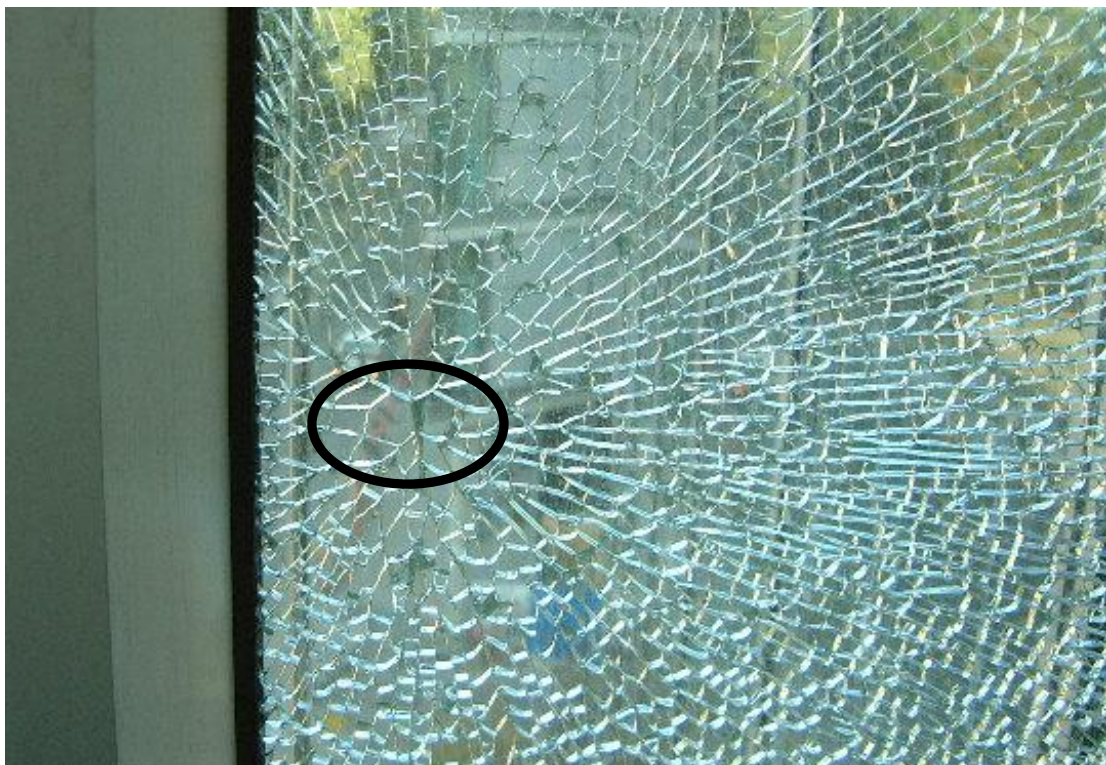
In this case, we find a characteristic breakage in the shape of butterfly. Many articles and publications exist on the subject. The phenomenon is inherent to thermally toughened glass, and can therefore not be considered a hidden defect of the product.

Typical breakage starting from a NiS inclusion

But, in the case of thermally toughened glasses, NiS reaches its stable structure at high temperature at the beginning of the operation of tempering when temperature of the glass is about 650°C. The rapid cooling which follows does not leave time to NiS to reach its stable structure at low temperature before glass is not entirely solidified. Its transformation will therefore continue at the temperature of service of the glass and the related increase in volume can cause spontaneous breakage of the glass sheet.

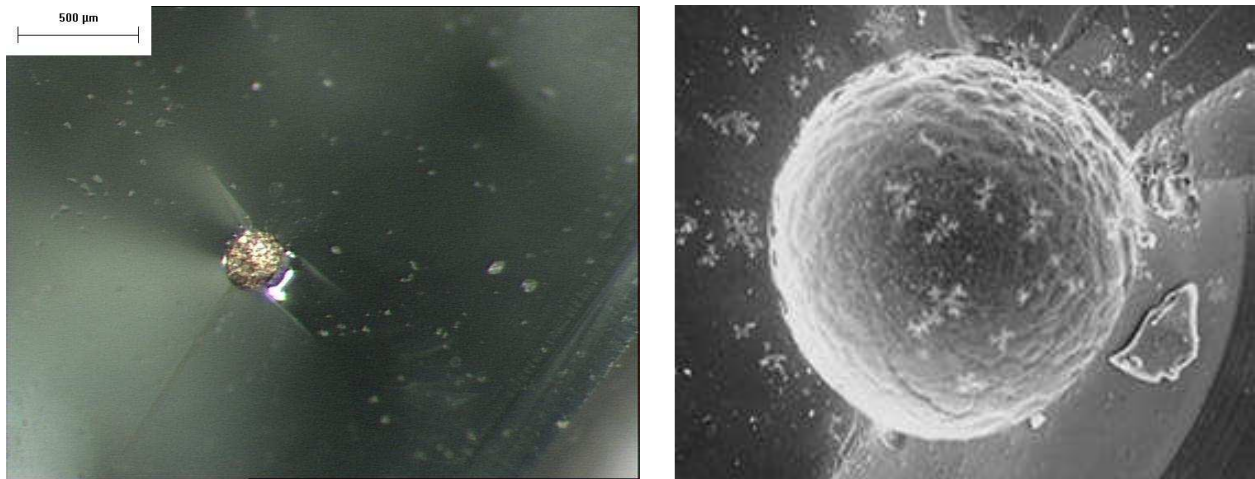
Zoom on a NiS inclusion

Glass can contain inclusions of various natures, coming from the raw materials, cullet or from the production facilities themselves. Among these, we find the Nickel Sulfide (NiS). These inclusions have a size of about 80 μm to 500 μm . They have the distinction of having a different crystalline structure at low and high temperature so that their volume is greater at low temperature.
